Valve Leakage

of Investigation
ious losses in a Steam Engine

Paul Munoz
6/14/04

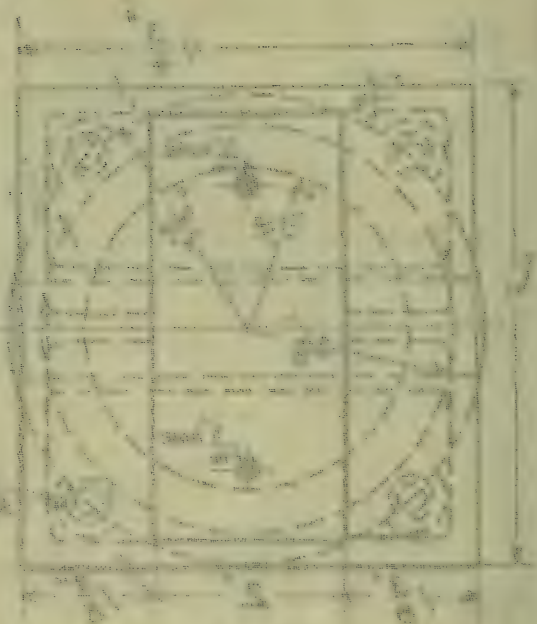
Diagram of Valve of Balance Ring
of Submarine Engine
Scale 1/2"

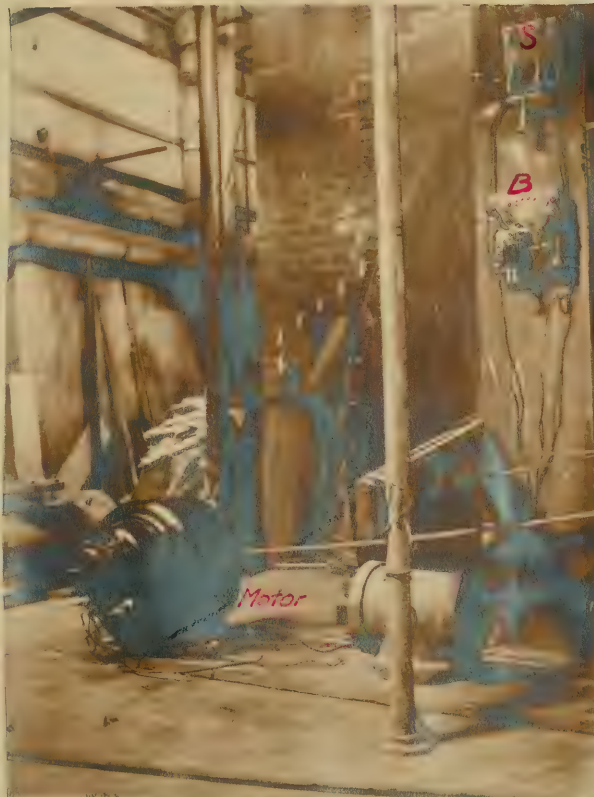
Fig 3

After Taking a card, a cord
Tied to the far end of the loop
was pulled until the pin
on the cross head moved to
1/2 in inside the loop. When taking
a card, the cord was released.
The revolutions of the engine
were recorded on a
continuous revolution
counter connected by a rod
to the top of the eccentric strap.
Two steam consumption tests
were run with the balance
ring on the valve. A one
horse power motor was then
connected through a switch
(S Fig 3) and a starting box
(B) to the 110 volt mains of
the building. This motor

was belted to a wooden pulley attached to the eccentric sheave. The steam passages of the engine were then plugged up and a leakage test was run.
